Some Answers to the November 2012 Beacon "Find the Problem" Contest

January 2013

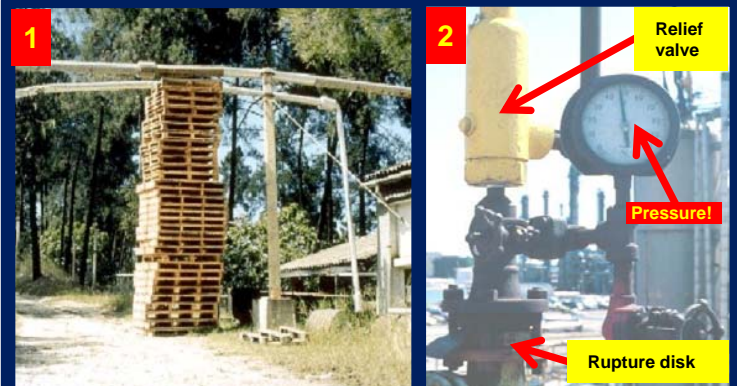
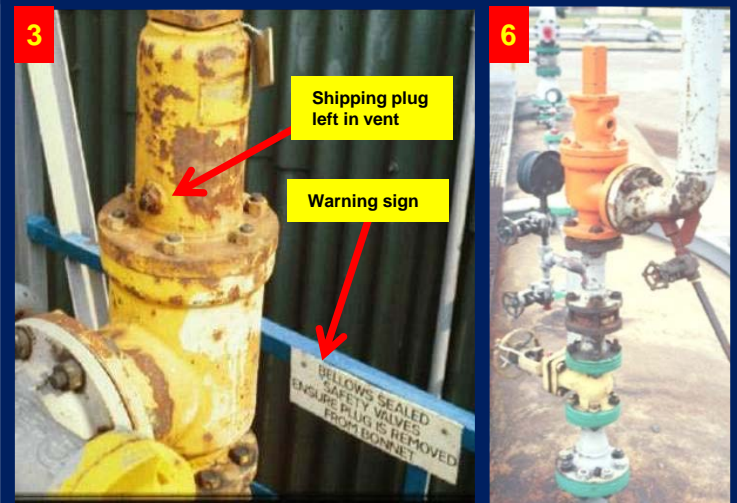
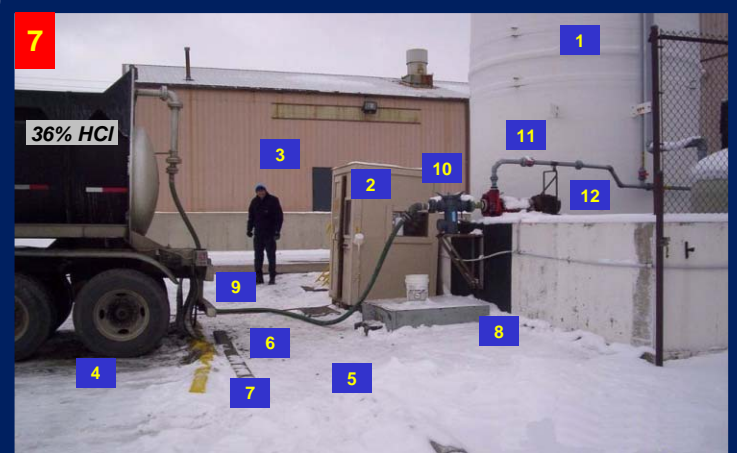
1. This is an easy one! Piping support is extremely poor!
2. The pressure between the rupture disk and the relief valve compromises the integrity of the emergency pressure relief system. Rupture disks burst when the difference between the upstream pressure and the downstream pressure exceeds the rupture pressure. If there is pressure downstream of the disk, it will not burst at the intended process pressure.

3. Despite the warning sign, the plug in the bonnet of this bellows sealed safety valve (which protects the valve during shipping) has not been removed. This will affect the pressure at which the valve opens.

4. Flexible hoses are being used to connect piping which does not fit together properly. Also, the flange on the right appears to be missing at least one bolt and the faces of the flange do not align properly.

5. All of these pumps are identical in appearance and there is no evidence of any labeling.
6. The valves and other pipe fittings on the inlet of the relief valve (RV) result in greater inlet pressure drop, which could cause relief valve chattering. The block valve on the RV inlet does not appear to have anything to prevent closing it and isolating the RV from the process.

7. There are many hazards in this photograph. Here are some of them, (you may find others!): (1) no visible label on the storage tank; (2) no eye wash or safety shower in the area; (3) the person in the picture is not wearing any personal protective equipment; (4) no chocks at tank truck wheels; (5) no visible spill containment; (6) many tripping hazards (and slipping hazards from the snow); (7) little or nothing to prevent backing the truck into the shed and unloading piping; (8) inadequate platform to access the unloading connection; (9) no way to drain the hose when unloading is complete; (10) no pressure gages anywhere on the unloading piping; (11) the valve handle downstream of the pump is too high; (12) the unloading piping is poorly supported.
