**BUILDING  
PROCESS SAFETY  
CULTURE:  
Tools to Enhance  
Process Safety  
Performance**

## Flixborough Case History

[The following information has been taken from the UK government publication *The Flixborough Disaster – Report of the Court of Inquiry*. While this summary has been condensed and paraphrased, it is believed to be consistent with the facts and conclusions outlined in the report.]

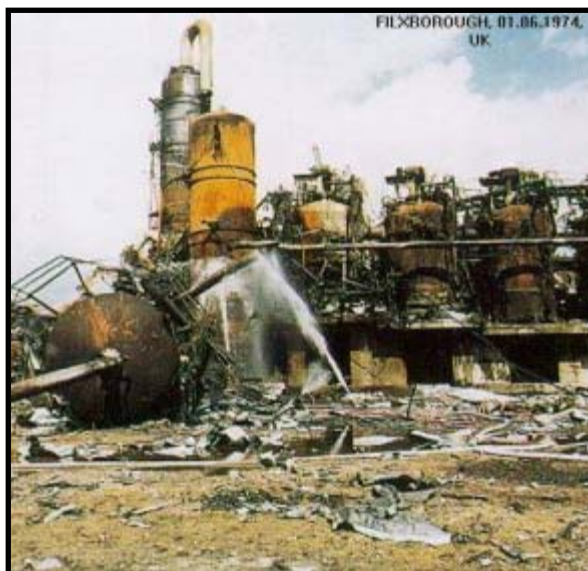
On June 1, 1974, the Flixborough Works of Nypro (UK) Limited experienced a massive vapor cloud explosion. 28 employees were killed and 36 injured (18 of the fatalities were in the control room building, which collapsed during the explosion). In addition, hundreds of persons off-site were injured, 53 with injuries significant enough to be classified by the authorities as “casualties.” Fortunately, there were no off-site fatalities, and the on-site fatalities were limited by the fact that the explosion occurred during the weekend.

The explosion and subsequent fires totally destroyed the plant, which was never rebuilt. Over 1800 houses and 167 businesses in the surrounding communities were damaged

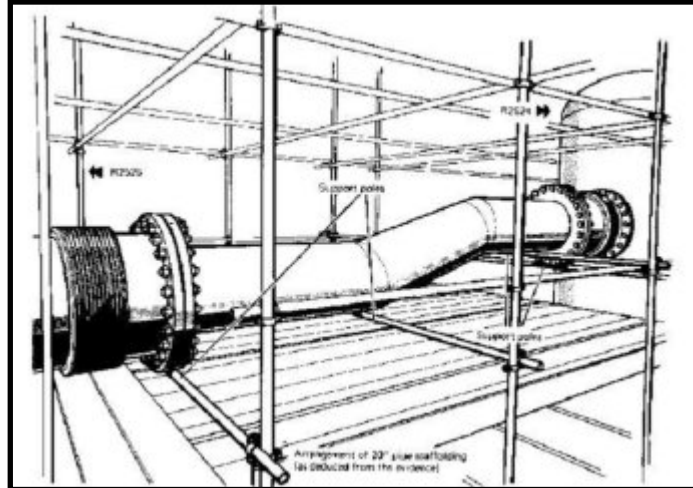
Reactor 5 developed a leak in the vessel shell and had to be removed for repair. In order to permit continued operation, a temporary piping assembly was fabricated to bridge the gap between the outlet on reactor 4 and the inlet on reactor 6. Because of the elevation changes, it was necessary to incorporate a dogleg in this piping jumper. This reduced diameter jumper (only 20 inch diameter pipe was available on site) was supported by scaffolding.

In the opinion of the investigators, the most likely source of the cyclohexane release was the dogleg piping jumper. It is believed that the unbalanced forces imposed on the bends in the piping, coupled with the flexibility introduced by the expansion bellows, allowed the inadequately supported and unconstrained jumper to oscillate. Ultimately, one of the bellows failed, releasing the process fluid.
