**A “GOOD IDEA” CAN TURN BAD . . .**

**WHEN YOU IGNORE MANAGEMENT OF CHANGE!****Here's What Happened:**

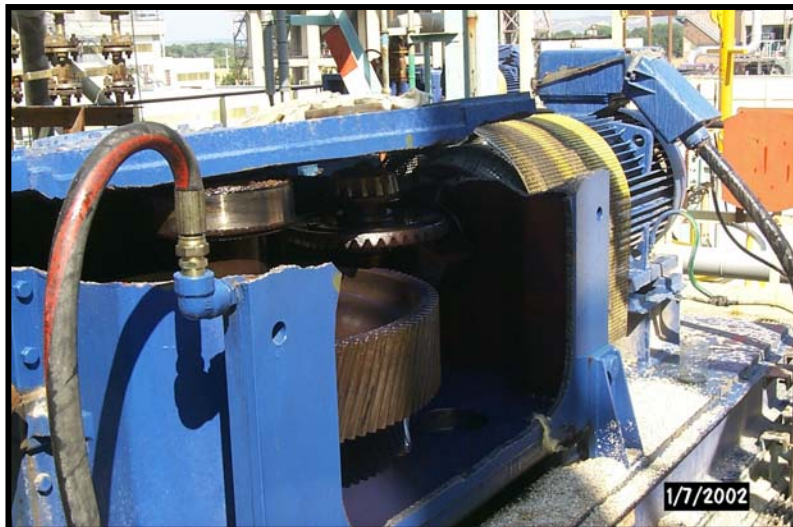
A mechanic was draining oil from this large gear box. The oil was draining out **very** slowly, so he decided to speed the job up by connecting an air hose to push the oil out faster. It didn't take long for the results shown to happen. The cast iron gear box fractured, blowing a large piece off and onto the floor. Fortunately, no one was hurt.

- The gear box was not a pressure vessel
- More air was added than could be vented, so the pressure built up
- MOC was not used to review the change

- Many pieces of equipment in a chemical plant are NOT designed for pressure. Check the equipment folder, but if there is no ASME code stamp, assume that it is not pressure rated.
- Adding air to the gear box was a change and should have been checked through the site's MOC process.
- Be alert to subtle changes that might not be safe.

Good ideas improve operations and reduce risk every day. However, before implementing a good idea, it is essential to review the change to ensure that it doesn't introduce any new hazards or risks to the workplace. In this incident, the mechanic should have recognized what he was about to do as “not like-in-kind” and reviewed the change through the MOC process. This would have identified that the gear box was not designed for pressure.
