Manage Temporary Changes!

October 2012

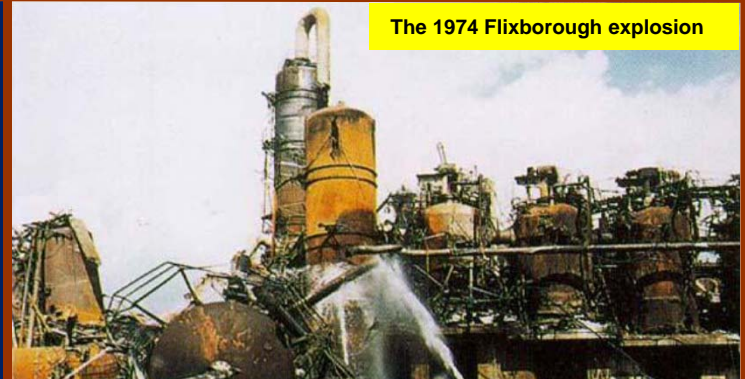
The 1974 Flixborough explosion

This incident has several things in common with the June 1974 explosion in Flixborough, England (June 2004 *Process Safety Beacon*). The Flixborough explosion killed 28 workers, injured 36, and had a major impact on process safety management systems and regulations throughout the world. The pipe which failed at Flixborough was much larger, but some common characteristics of this incident and the Flixborough explosion include:

- A management of change review was not done for a temporary piping modification.
- The temporary piping did not follow appropriate engineering standards, and the piping was not properly supported.
- Stress on temporary piping was one factor in the failure.
