Corrosion under insulation

June 2019

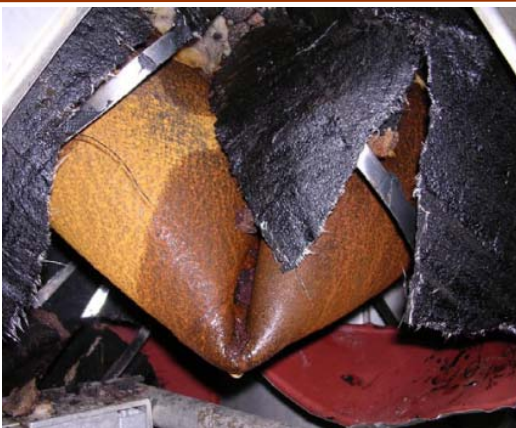
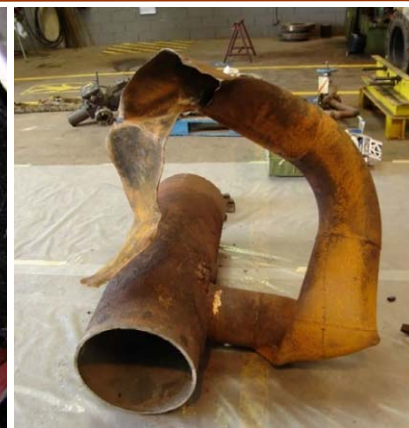
A plant experienced a catastrophic piping failure of an 8-inch (200 mm) insulated steel line containing noncorrosive cracked gas (~ 40% ethylene). The incident started as a pinhole leak that was detected by operators. The pipe failed while the line was being isolated and depressurized. Fortunately, the line folded as it failed, which limited the size of the release. There were no injuries.

The line was 30 years old. It was in a regeneration service where operation alternated among three different temperature conditions:

- Normal operation at 1 °F (−17 °C)
- Regeneration at 428 °F (220 °C)
- Standby at ambient temperature

These changes in operating temperature caused condensation of moisture from the atmosphere on the outside of the pipe, and re-evaporation. This is a well-known high-risk situation for corrosion under insulation (CUI). It can easily be missed if the mechanical integrity team is not aware of the changing operating conditions.

- Understand which equipment in your plant is most susceptible to CUI. Some examples include steel pipe, pipe in cold or cycling service, and pipe containing a corrosive fluid. Your corrosion experts can provide information to help you understand CUI in your plant.

- When you walk through the plant, look for damaged insulation, jackets, or seals where water can enter. These areas should be inspected, and the insulation repaired.

- Immediately report signs of any leak that you observe. Look for signs of liquid inside the insulation jacket such as drips or puddles (even if "only water"), discoloration, rust stains, and blistering. Follow up to make sure the leak is repaired in a timely manner.

- If insulation is removed during maintenance or repairs, use this chance to check the equipment for signs of corrosion. Also, remember that the job is not complete until the insulation is replaced.
