**BUILDING  
PROCESS SAFETY  
CULTURE:  
Tools to Enhance  
Process Safety  
Performance**

## Flixborough Case History

[The following information has been taken from the UK government publication *The Flixborough Disaster – Report of the Court of Inquiry*. While this summary has been condensed and paraphrased, it is believed to be consistent with the facts and conclusions outlined in the report.]

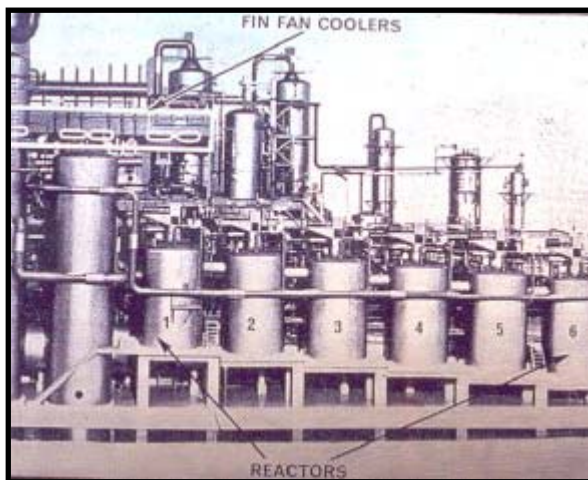
The Flixborough process involved the partial oxidation of cyclohexane to produce cyclohexanol and cyclohexanone, the latter being a feedstock to the production of caprolactum, an intermediate in the production of Nylon 6. Cyclohexane was recirculated through a series of six reactors operating at a nominal pressure and temperature of 125 psi and 155° C. The six reactors were arranged so that

each successive reactor was at a lower elevation than the prior, in order to allow the cyclohexane to flow by gravity from one reactor to the next. The reactors were interconnected by 28-inch diameter lines with corrugated expansion bellows installed at the vessel outlet and inlet flanges.

Reactor 5 developed a leak in the vessel shell and had to be removed for repair. In order to permit continued operation, a temporary piping assembly was fabricated to bridge the gap between the outlet on reactor 4 and the inlet on reactor 6. Because of the elevation changes, it was necessary to incorporate a dogleg in this piping jumper. This reduced diameter jumper (only 20 inch diameter pipe was available on site) was supported by scaffolding.

In the opinion of the investigators, the most likely source of the cyclohexane release was the dogleg piping jumper. It is believed that the unbalanced forces imposed on the bends in the piping, coupled with the flexibility introduced by the expansion bellows, allowed the inadequately supported and unconstrained jumper to oscillate. Ultimately, one of the bellows failed, releasing the process fluid.

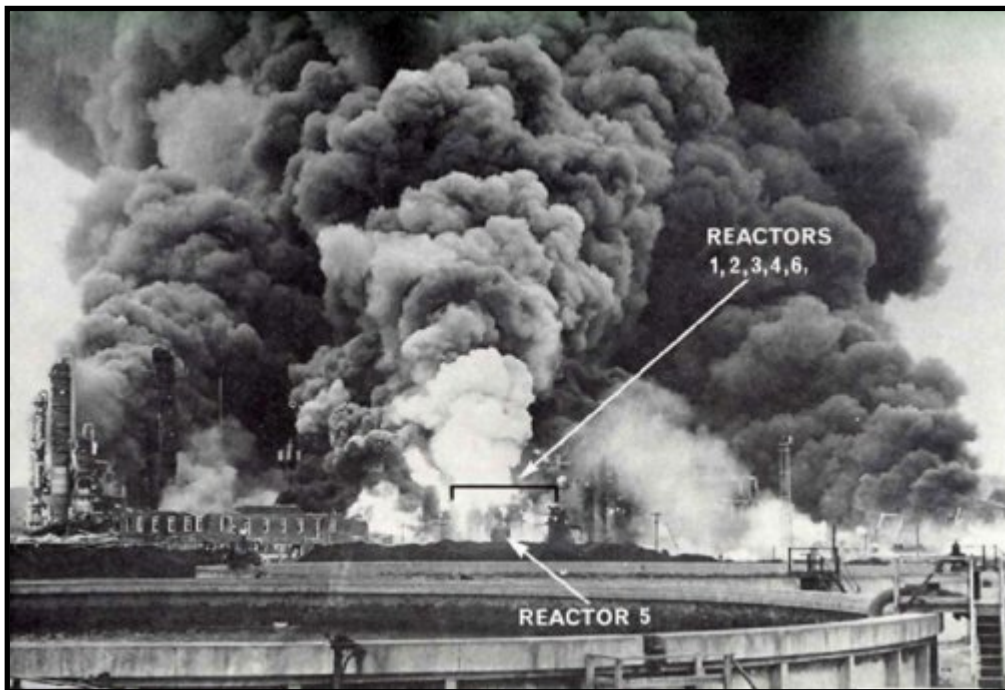
- 95 • While calculations were made to confirm that the 20-inch pipe could withstand the normal working pressure, no consideration was given to the bending moments or hydraulic thrusts that would be imposed on the assembly due to its dogleg configuration . There was no reference made to vendor manuals for the expansion bellows, nor to relevant British Standards.

- 100 • No drawing was made for the design, other than a chalk sketch made on the floor of the maintenance workshop.
- 105 • There were no quality assurance checks made on the fabrication or installation of the assembly other than a leak check at approximately 130 psi (for comparison, the relief valves [RVs] on the reactor system were set to open at approximately 155 psi). Applicable British Standards required that the assembly be tested at a pressure of 1.3x the system design pressure, which would have been above the RV set pressure.

- Nypro did not have an adequate system for evaluating and controlling changes to ensure that safety was not impacted (in fairness, our currently mature perspective on management of change did not generally exist within industry in 1974).
