April 2006

Mechanical Integrity

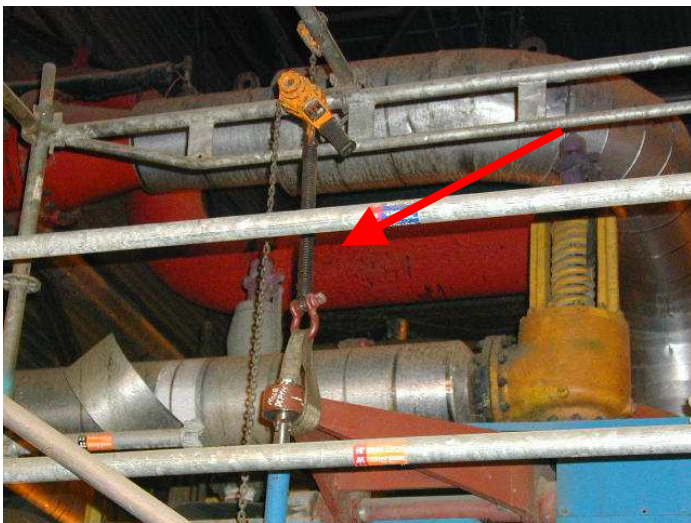
This picture shows an improvised pipe support made from scaffolding, springs and clamps.
