What is supporting your equipment?

February 2013

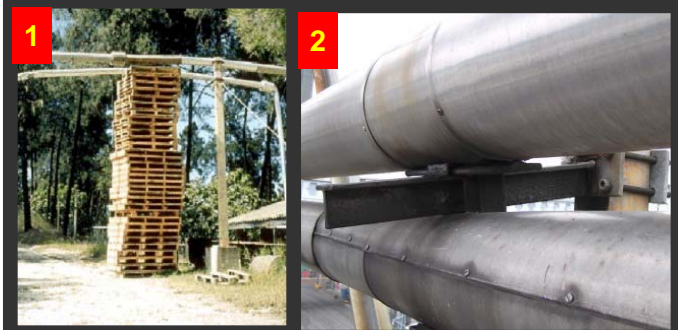
Picture 2– The steel supporting the pipes has bent, possibly because the weight of the pipes is more than the steel can support. Perhaps this was a result of a change – was a second pipe added without considering the design of the supporting steel?

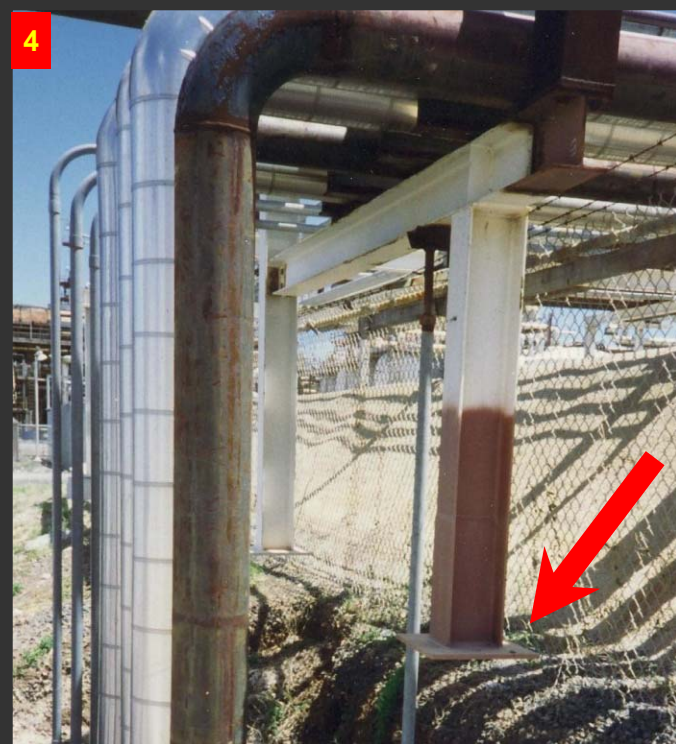
Picture 4 – Look closely – the steel supports are not touching the ground. They are hanging from the pipes rather than supporting them!

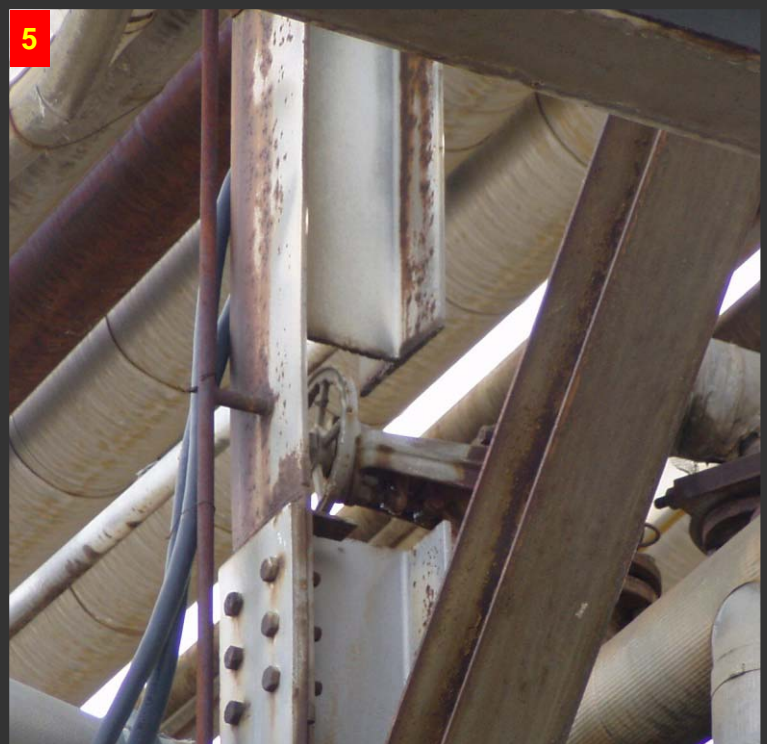
Picture 5 – Somebody has cut out a section of the structural steel to make room for a valve!
