## Do Not Mix Incompatible Materials in Storage Tanks

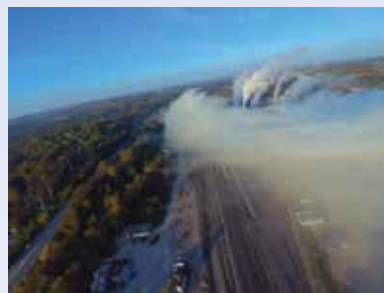
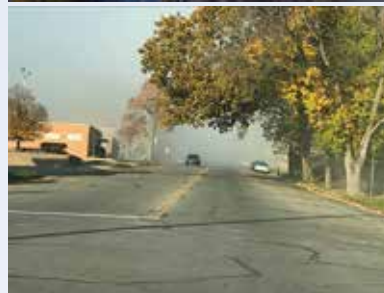
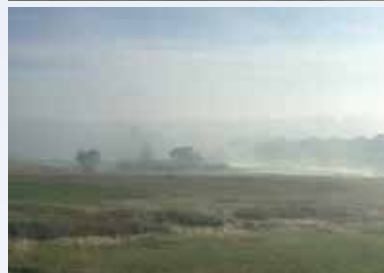
▶ The chlorine gas cloud released in Kansas affected members of the surrounding community — some required medical treatment while others were forced to seek shelter.

- Understand the materials used at your plant, including any potential hazardous interactions. The July 2016 Beacon describes the CCPS Chemical Reactivity Worksheet — a tool that can help you determine hazardous chemical interactions.
- Check (and double-check) all of the documentation and labeling on incoming shipments of raw materials to confirm that the material is correct.
- Follow your plant's procedures for identification and unloading of raw material shipments.
- Ensure that all piping and equipment in your raw material unloading areas are clearly labeled. Tanks containing incompat-

ible materials should not have any connections between them.

- If the area where raw materials are unloaded has confusing piping, or if incompatible materials are unloaded in locations near each other, inform management so that improvements can be made to the layout or procedures.
- Make sure supplier truck drivers who are responsible for unloading material into storage tanks at your plant are familiar with your unloading facilities and procedures.
- Read the March 2009 and April 2012 Beacons for more examples of incidents involving the unloading of incompatible materials into tanks.
