# Some Short-Cuts May Cut Lives Short

#### October 2024

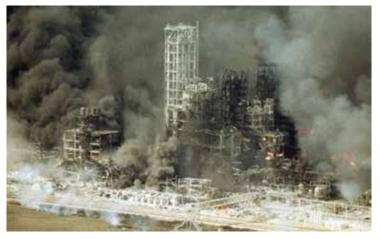
▲ Figure 1. In 1989, a fire at a plastics plant in Pasadena, TX, began after operators bypassed proper maintenance procedures. The ensuing fires took 10 hours to be brought under control (1).

Thirty-five years ago, 85,000 lbs (39 m.t.) of process gas, mostly ethylene, was released from a plastics plant in Pasadena, TX. The cloud ignited two minutes later in an explosion. Debris flew as far as 6 mi (10 km), luckily hitting no one. The ensuing fire caused the explosion of a 20,000-gal (75 m<sup>3</sup>) isobutane tank; other explosions followed. On the site, 23 employees and contractors were killed, and another 314 workers were injured. Extensive damage to the site and business interruption caused financial losses of about \$1.5 billion.

Workers were clearing a settling leg that was used to collect polymer in a polyethylene loop reactor. Company and industry safety standards required isolation by means of a double-block system or the use of a blind flange. However, the plant used a simpler procedure with a single isolation point. In addition, the company failed to enforce an effective permit-to-work system for employees and contractors.

The accident investigation established that the single ball valve isolating the settling leg from the process was opened at the time of the release. The air hoses to the valve had been connected, which was against procedures, and cross-connected so that the air used for closing the valve opened it instead. The investigation concluded that process gas was intended to push down some polymer that blocked the pipe, but that could not be confirmed.
